Pre-Purchase Structural Inspection Report

Inspector	Andrei Rotaru
Date of inspection	10am, 15 August 2019
Weather Conditions	Prevailing conditions at the time of the inspection: sunny, 17 degrees Celsius
Description of the property inspected	<p>The property inspected was constructed circa 2000 and consists of 4 bedrooms, and 3 bathrooms. The property has a double garage, steel patio and a smaller steel shed.</p> <p>The dwelling is constructed on a concrete slab with double brick walls, timber roof frame and tiled roof covering.</p>
Purpose of inspection	The purpose of the inspection is to provide advice to a prospective purchaser or other interested party regarding the condition of the property at the time of inspection.
Scope of inspection	The inspection comprised of a visual assessment of accessible areas of the property to identify major defects to the building structure and to form an opinion regarding the general

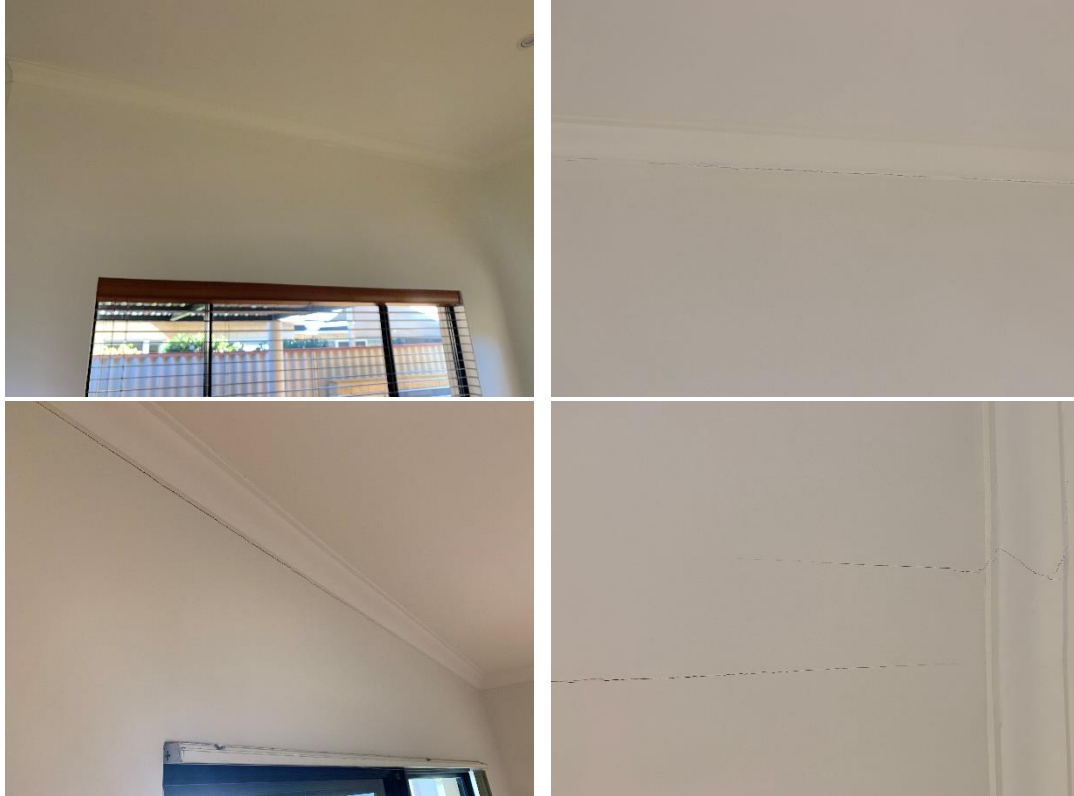
There is some minor ceiling cracking, cornice joint cracking and cornice separation throughout the dwelling and can be attributed to expected building settlement.

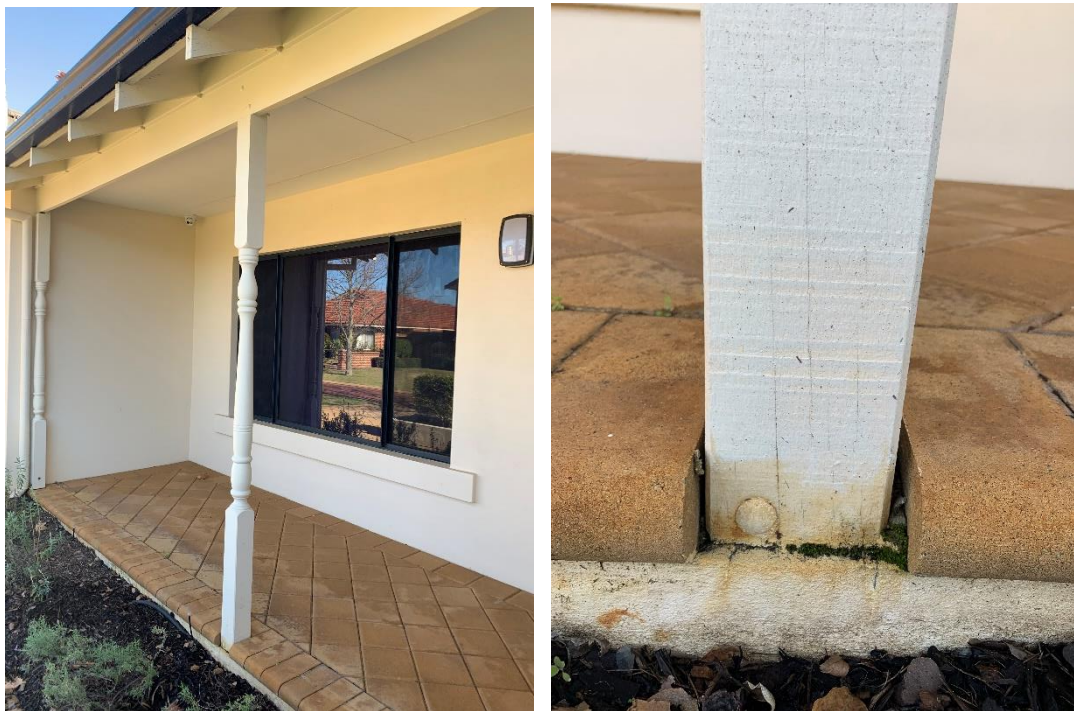
The verandah timber posts are currently in good condition. However, to maximise the durability of the posts, the installation should be undertaken in such a way that a clearance between the concrete and the bottom end of the post is achieved. This prevents moisture from decaying the timber over time.

The timber posts should be inspected for signs of decay in the future and replace as required.

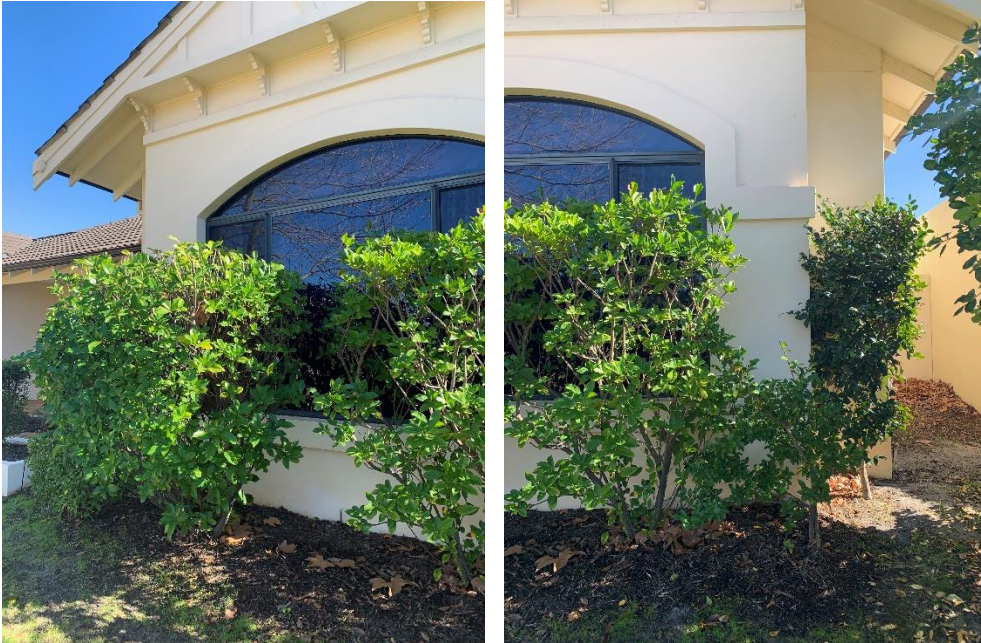
Trees and shrubs in close proximity to foundations can cause a variety of structural issues over time. The CSIRO has produced *Building Technology File 18-2011 Foundation Maintenance and Footing Performance: A Homeowner's Guide* which provides some great guidance to ensure that long term performance (for more information visit <https://www.publish.csiro.au/book/7076/>).

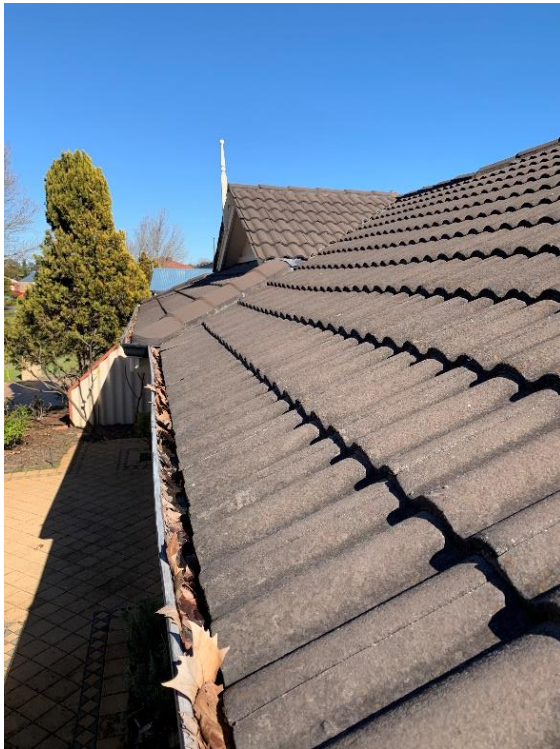
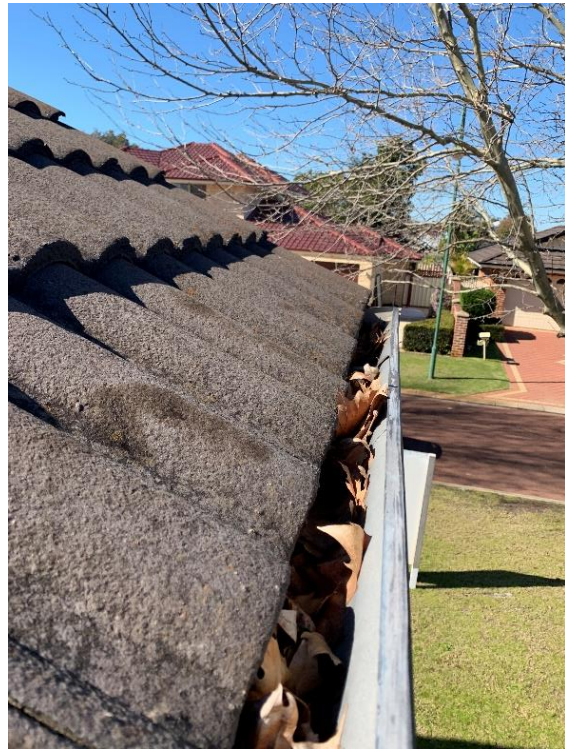
Generally, gutters need regular cleaning of leaf matter. Decaying leaf matter causes corrosion in gutters and blocks water flow. Overhanging trees to gutters and valleys can cause rapid build-up of leaf matter, restrict water flow, and may damage the roof covering. Keeping them trimmed back or removed may be a worthwhile consideration and would help prevent water ingress from blocked water flow.

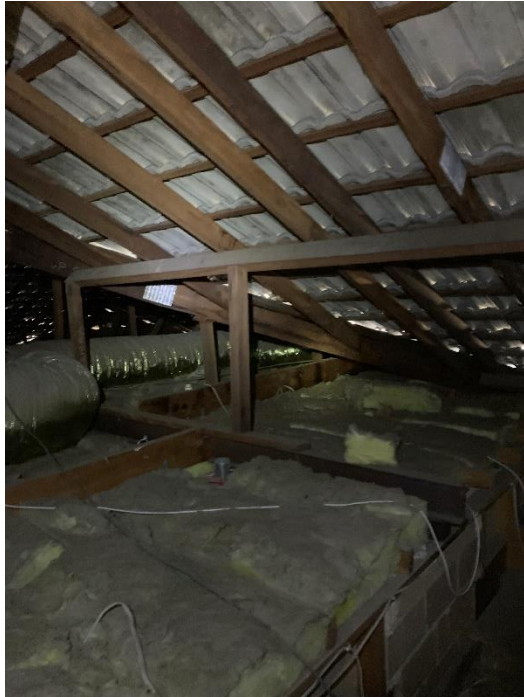
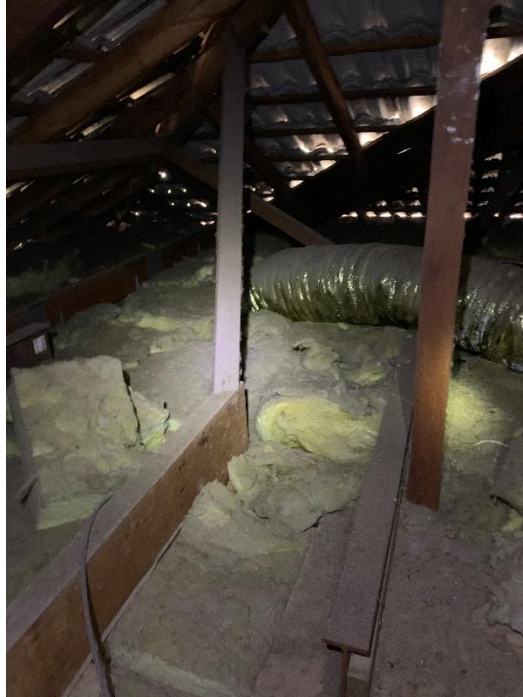
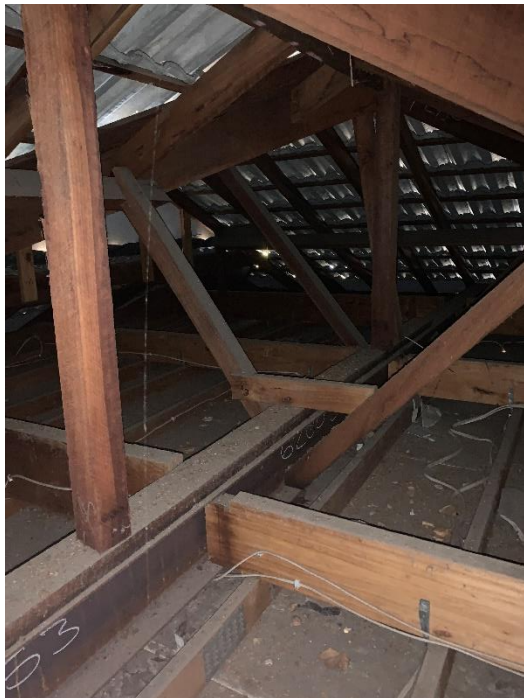
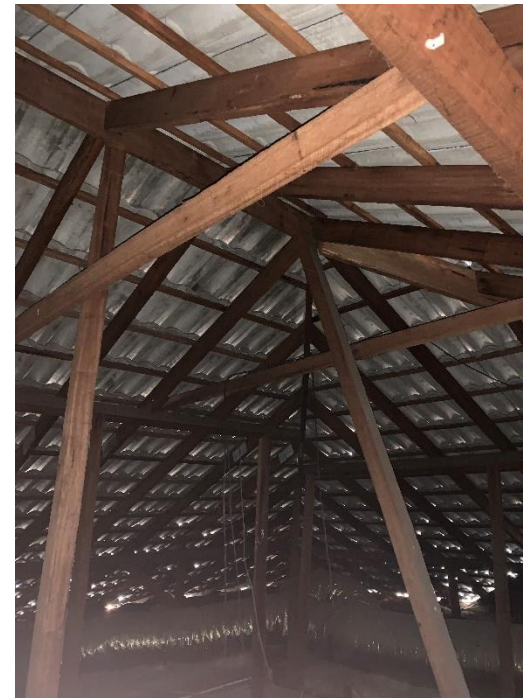
Insulation was in place across the entire ceiling space and the air-conditioning ductwork provided some obstruction in accessing some of the areas.

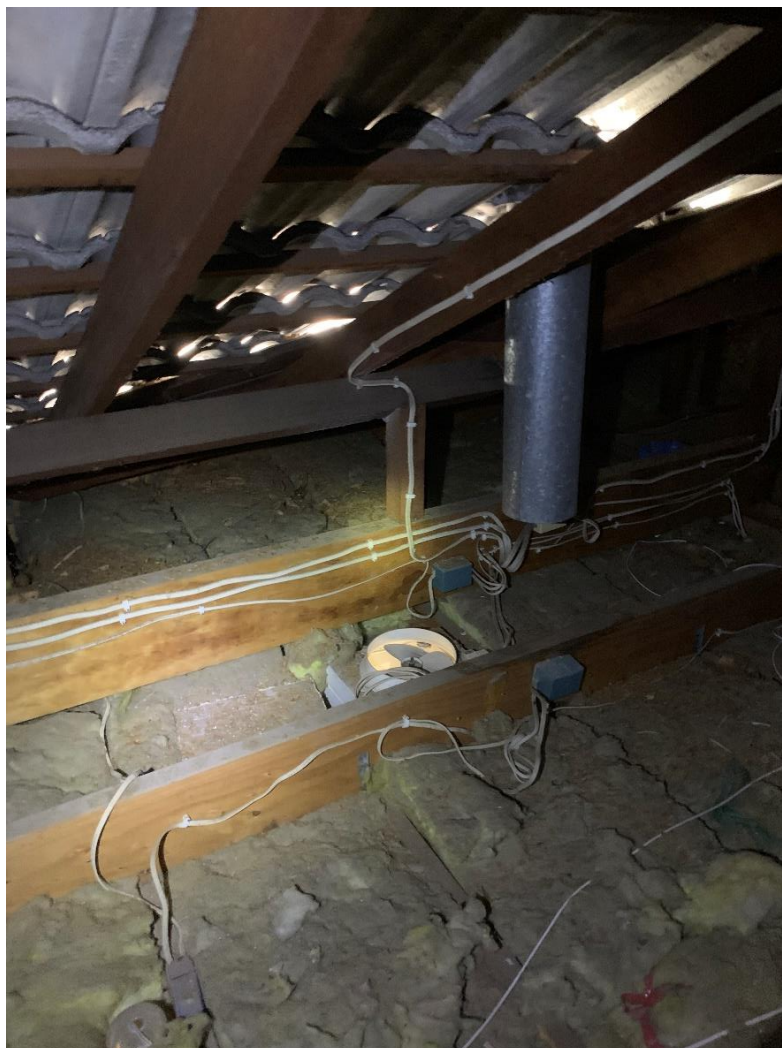
One of the exhaust fans is venting in to the roof space. This is not compliant with National Construction Code (NCC).

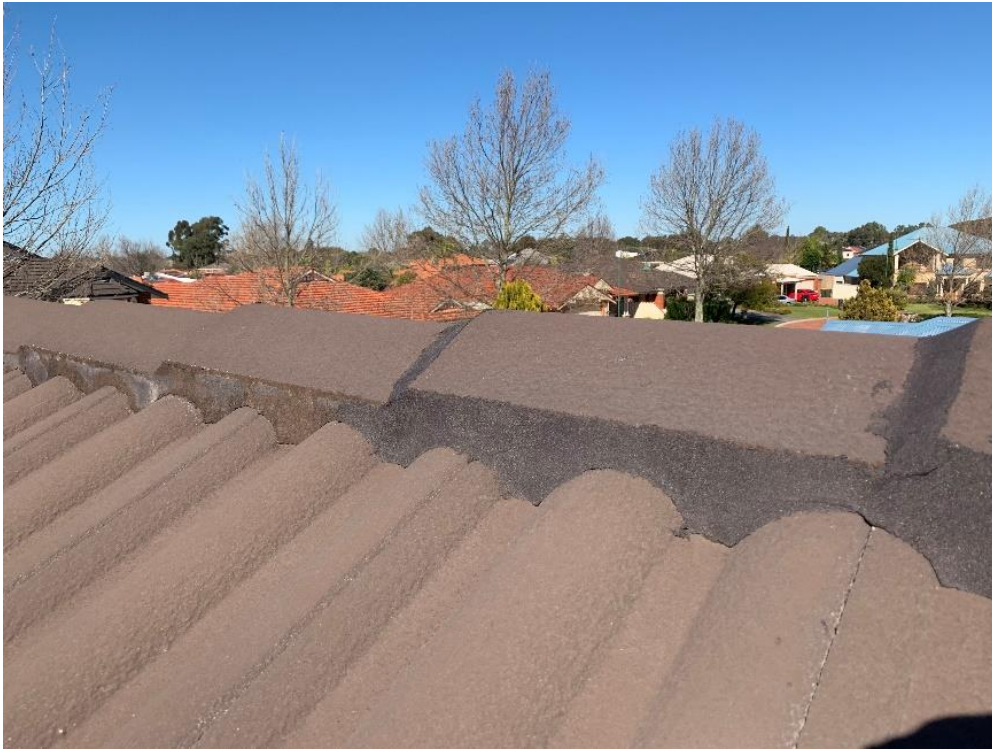
It was noted that ridge capping re-pointing was undertaken in the past perhaps as part of routine maintenance.

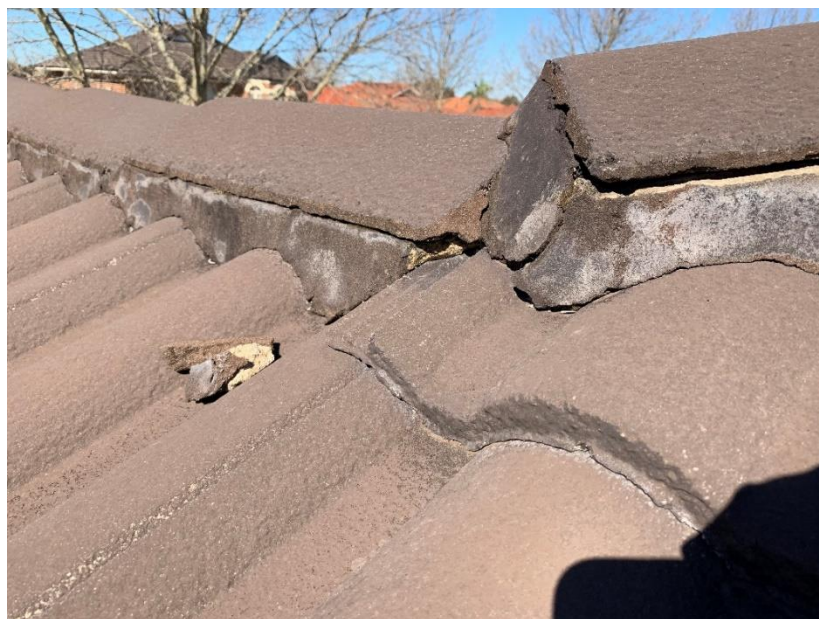
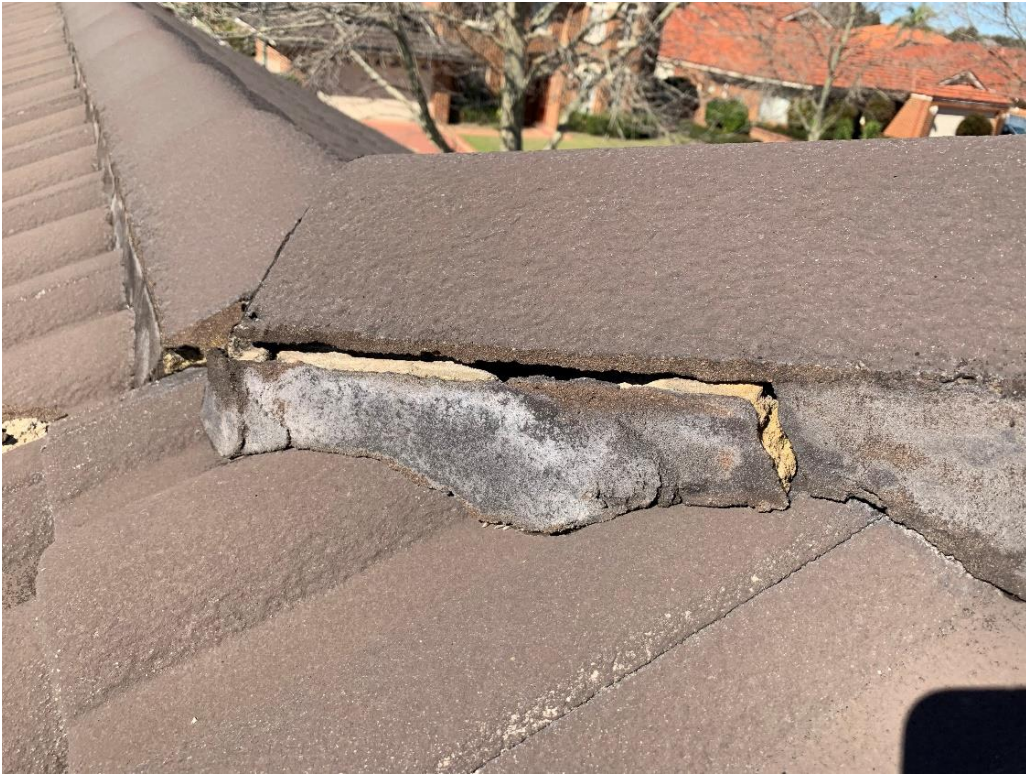
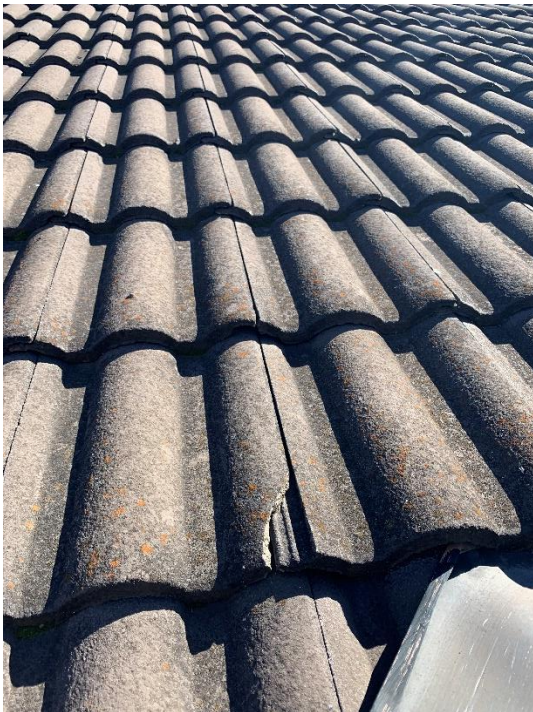
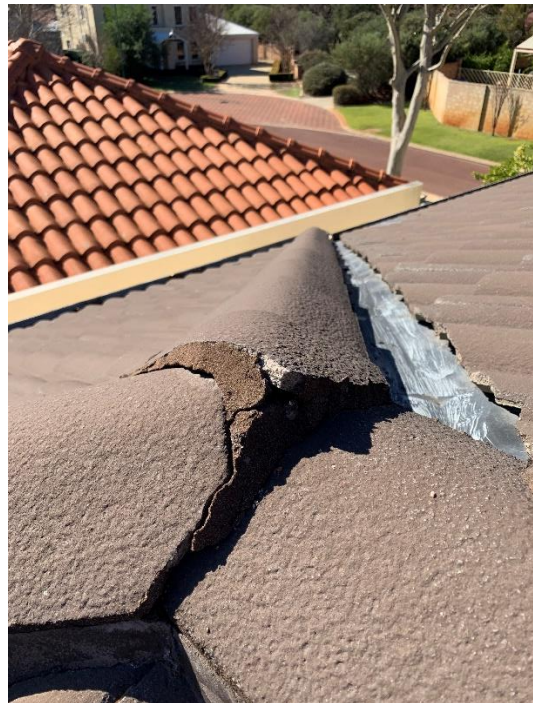
However, cracks were evident in other areas on roof hips and in the ridge capping. It is recommended that the tiled roof is repointed as this is required a several locations. A roofing contractor should be engaged and the re-application of pointing mortar is advised to further protect against water penetration. This water penetration can lead to significant damage over time if not addressed.

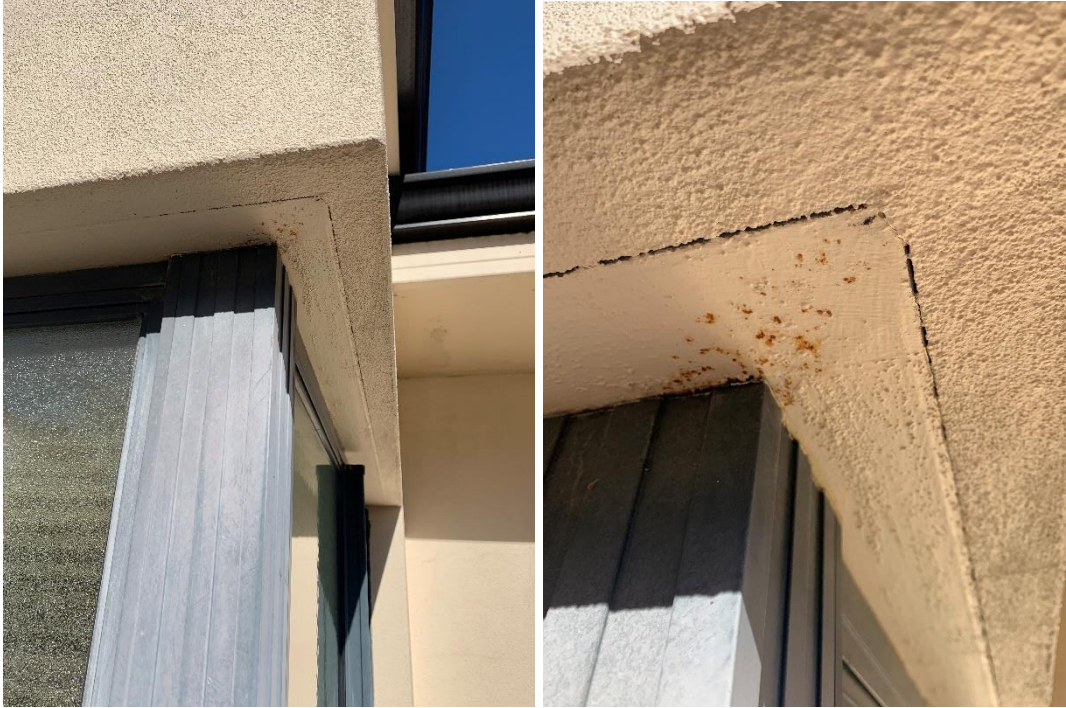
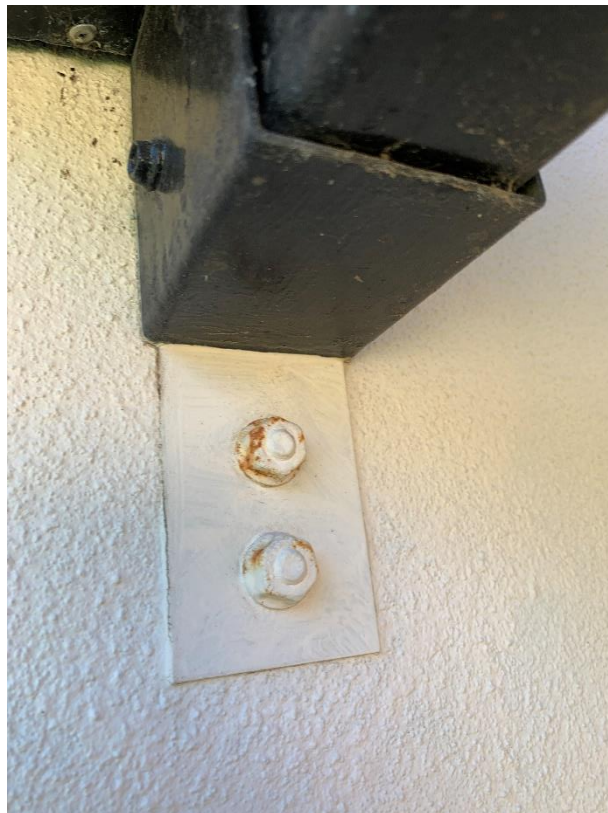
There is some very minor corrosion observed on the window lintels and the steel patio fixings. Although this isn't a concern now, it should be rectified in the near future to ensure long term performance.

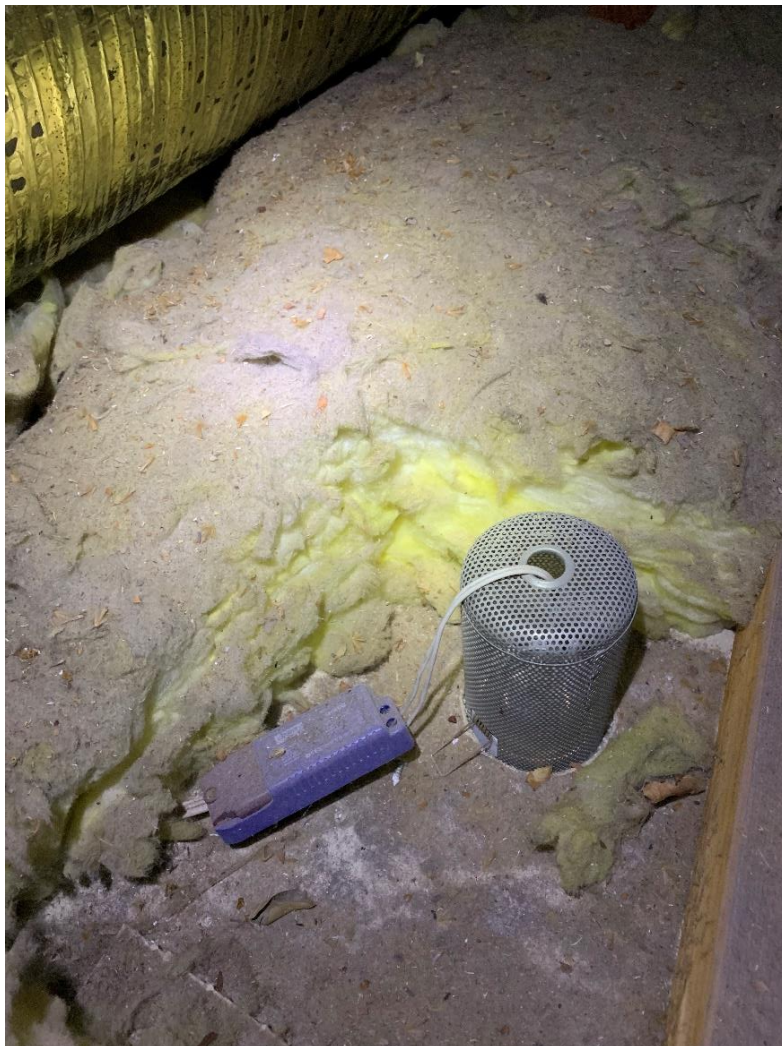
Recessed luminaires such as downlights and their auxiliary equipment (such as transformers) need to be installed in a manner designed to minimise temperature rise and prevent the risk of fire. We recommend that a licenced electrician is appointed to inspect the roof space and certify that all downlights and transformers are correctly installed and have enough clearance to insulation.
